Casting Defects in Iron and Steel

6.1 CASE STUDY: FAILURE OF EXHAUST OUTER CONE OF AN AEROENGINE

6.2 CASE STUDY: FAILURE OF SEALING RINGS OF CENTRIFUGAL BREATHER OF AN AEROENGINE

6.3 CASE STUDY: FAILURE OF GRINDING ROLL OF A BOWL MILL

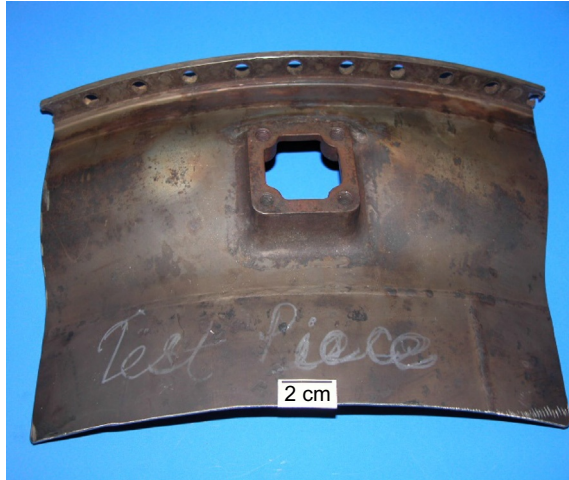
Visual Examination: A portion of the exhaust outer cone in the as-received condition is shown in Fig. 6.1.1. From the portion it can be visualized that the exhaust outer cone is made of a sheet metal that has been welded to the

Fig. 6.1.1 Portion of the exhaust outer cone in the as-received condition.

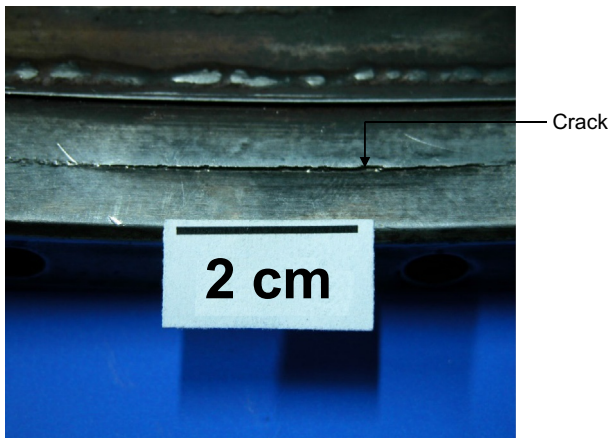
Fig. 6.1.2 Close-up of the front flange showing the crack.

front flange. A crack of about 60 mm length was observed on the front flange (Fig. 6.1.2). The crack was developed on the arm of the 'L' shaped flange which is welded to the cone. The section thickness of the flange on this arm was about 1.25 mm.

The front flange of the exhaust outer cone developed a crack due to casting defects viz., microcavities, porosities, and slag inclusions which propagated under fatigue-loading conditions over a distance of about 60mm in length and entire section thickness resulting in a through and through crack. The oil leakage was due to this cracking of the front flange in the exhaust outer cone of the aeroengine.

1. If casting is unavoidable it should be carried out with utmost control so that no casting defects are left in the component.
2. The front flange should be subjected to radiography for checking casting defects before assembly. The NDT check should also be incorporated in the quality line during maintenance and overhaul for the presence of crack-like defects.

3. Closed die forging is considered a better manufacturing method for components of lower thicknesses like that of the front flange of the exhaust outer cone as compared to casting; in order to produce a defect-free product.

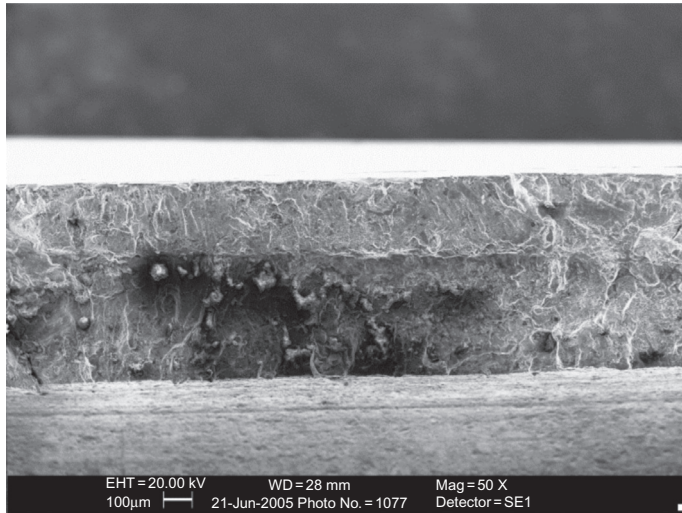
Fig. 6.1.3 SEM fractograph of the fracture surface showing about two-third of the fracture being coarse with large cavities and inclusions, and almost smooth fracture of the remaining one-third portion.

third of the fracture surface showed a mixed mode of smooth and coarse fracture (Fig. 6.1.3). Large cavities with some inclusions were noticed in the coarse region of the fracture surface. One such cavity containing some inclusions is shown in Fig. 6.1.4. The inclusions at two different spots were

The defective portion of the flange occupied about two-thirds of the section thickness from where the crack originated as seen by SEM fractographic examination. Casting defects can reduce the effective cross-sectional area especially in lower cross sections of components. Lower cross sections will not be able to withstand the designed load as load-bearing capacity decreases which will in turn have an adverse effect on the fatigue strength of the component.

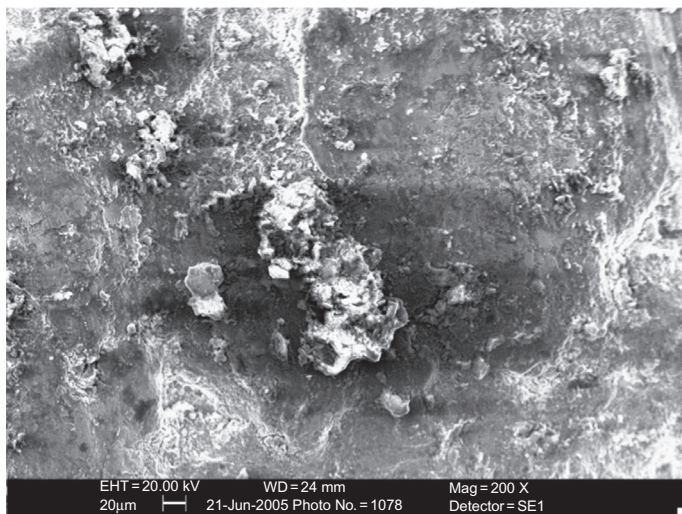
Fig. 6.1.4 SEM fractograph of the fracture surface showing one of the cavities containing some inclusions.

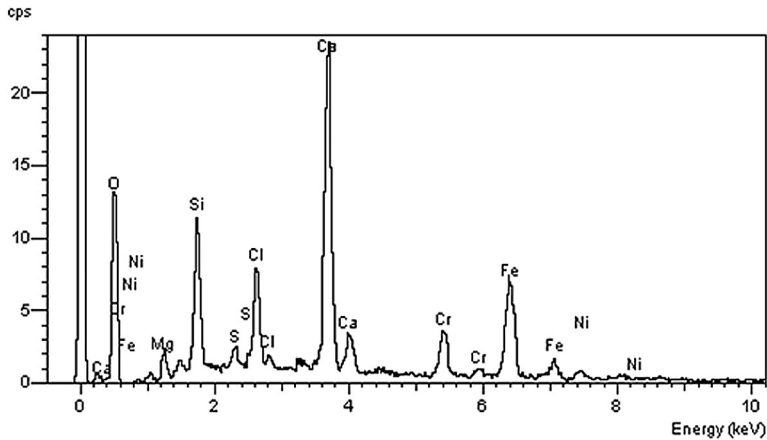
Fig. 6.1.5 EDAX spectrum of inclusions showing the presence of Si, Ca, Mg, Cl, O, and S in addition to Cr, Ni, and Fe.

analyzed by energy dispersive X-ray spectroscopy (EDAX) and found to contain Si, Mg, Ca, Cl, S, and O in addition to Cr, Ni, and Fe (Fig. 6.1.5). The coarse region of the fracture surface revealed a quasi-cleavage fracture (Fig. 6.1.6). The smooth area beyond the coarse fracture area showed characteristic fatigue striations (Fig. 6.1.7).

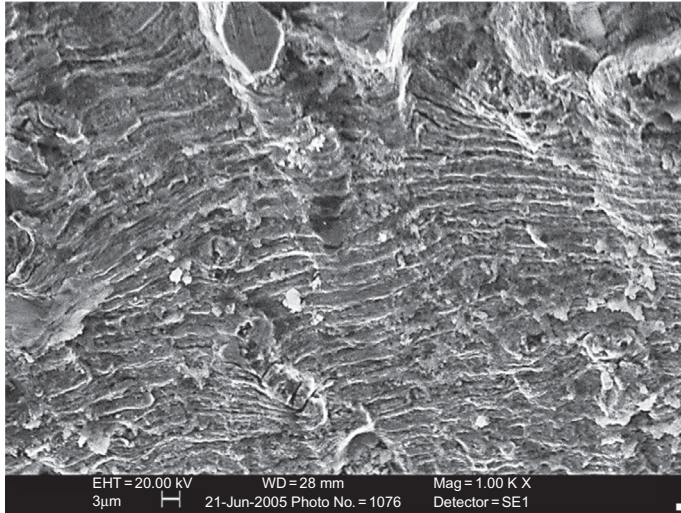
Fig. 6.1.7 SEM fractograph of the smooth region of the fracture surface showing fatigue striations.

The thicker arm (containing the drilled holes) of the flange was about 3mm thick while the thinner arm which was welded to the cone portion was about 1.5mm thick. The lower thickness of the thinner arm of the flange was probably designed so as to match with the section of the cone portion with which it is joined by welding. If maintaining such thin section of this arm of the flange was a design requirement, then manufacturing it by casting can be considered as an inadequate design. Moreover, the control over the casting method was very poor because of which the casting contained a large number of interdendritic microcavities and slag pockets. The cavities and slag pockets over about two-thirds of the section thickness reduced the effective section size as well as acted as stress raisers which initiated the fatigue crack. The crack had initiated from the center and propagated on both sides circumferentially under fatigue-loading condition as evidenced in fractography.

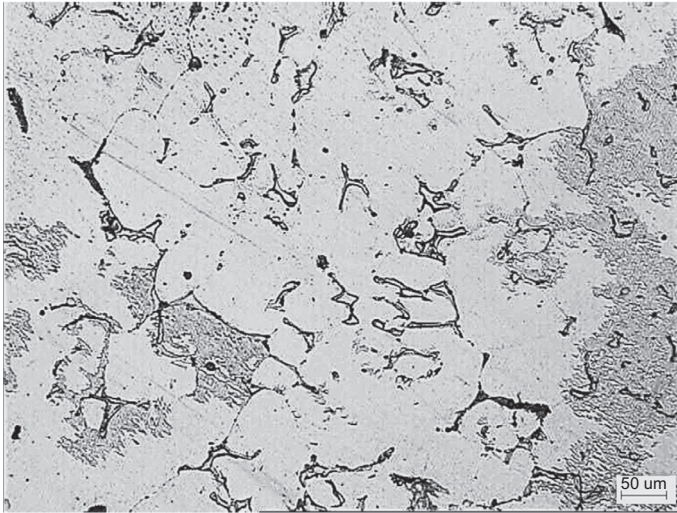
Fig. 6.1.8 Micrograph of the flange sample showing a dendritic microstructure and interdendritic microcavities. Etchant: Aqua regia.

Chemical analysis and microstructure suggested that the flange portion of the exhaust cone was an austenitic stainless steel casting nearly conforming to UNS-J92710/ACI-CF8C used in the as-cast condition. The casting contained a number of defects viz., microcavities, porosities, and slag inclusions.

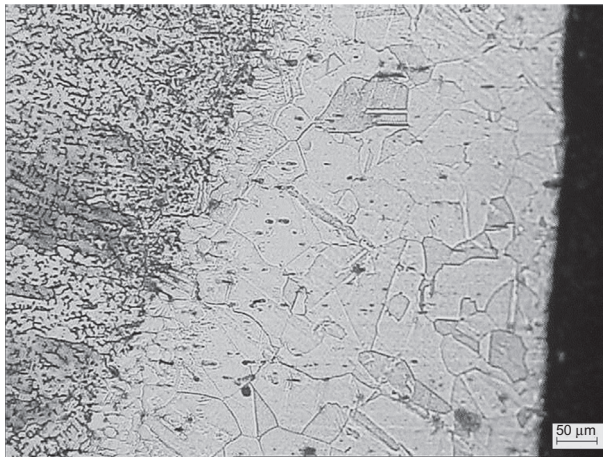
Fig. 6.1.9 Micrograph near the weld region of the sample showing equiaxed grains of austenite with annealing twins in the cone portion. Etchant: Aqua regia.

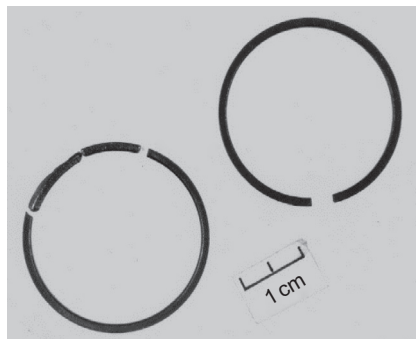
Visual Examination: The sealing rings in the as-received condition are shown in Fig. 6.2.1. The fracture surface when examined under stereomicroscope was seen to be coarse and crystalline.

Fig. 6.2.1 Failed sealing rings in the as-received condition.

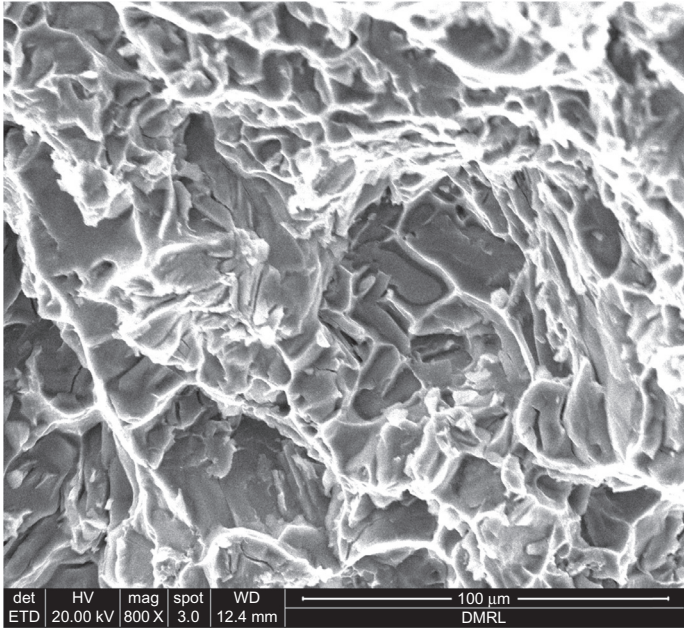
Fractographic Examination: On examining under SEM the fracture surface of sample (A) revealed transgranular cleavage fracture in the broken sealing ring while the sample (B) showed quasi-cleavage fracture (Figs. 6.2.2 and 6.2.3).

Fig. 6.2.2 SEM fractograph of the fracture surface showing transgranular cleavage fracture in sample A.

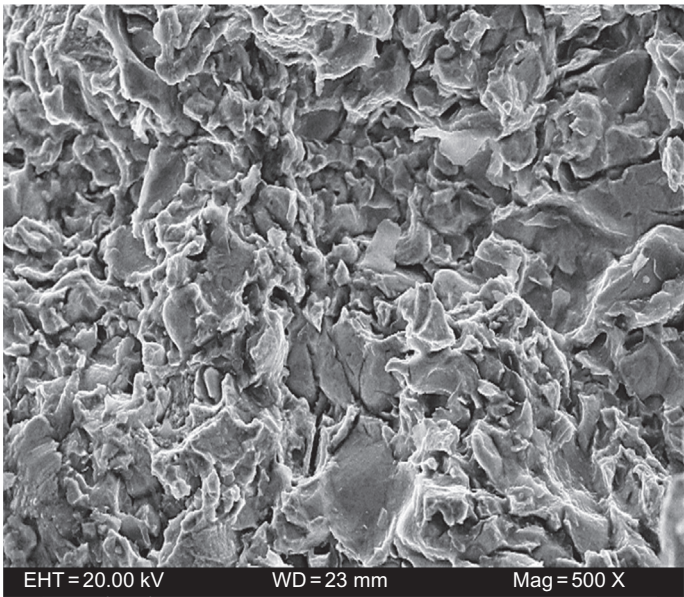
Fig. 6.2.3 SEM fractograph of the fracture surface showing quasi-cleavage fracture in sample B.

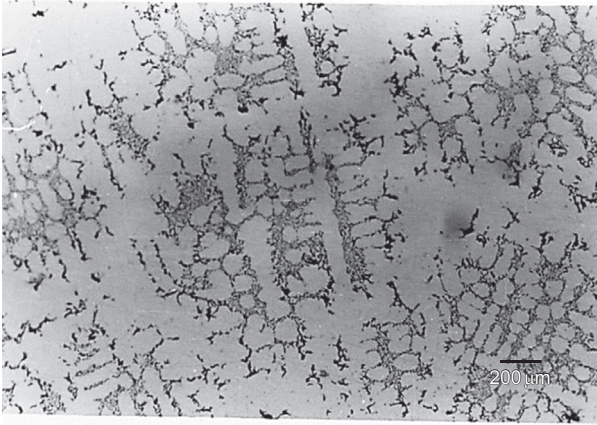
Fig. 6.2.4 A typical micrograph showing E-type graphite distribution in a section of sample A. Unetched.

Metallographic Examination: Sections of the two failed samples were prepared for metallographic examination. In the unetched condition, sample (A) showed interdendritic segregation of fine graphite flakes having preferred orientation i.e., E-type distribution as per ASTM A247 (Fig. 6.2.4) [1]. In the unetched condition, sample (B) showed random distribution of graphite flakes and rosette grouping, i.e., a mixed A-B type distribution (Fig. 6.2.5) [1]. On etching with 2% nital, the failed sample (A) revealed interdendritic segregation of finer graphite flakes with preferred orientation in a matrix of lamellar pearlite with free cementite (Fig. 6.2.6). On etching

Thus from the investigation, it is evident that the microstructure of the cast iron influences brittle fracture. Both E type and A-B type of graphite distribution caused failure of sealing rings. It is therefore necessary to control both the graphite morphology and distribution and also the free carbide by sound foundry practice. Inoculation, composition control, and cooling rate are the important parameters, which have to be judiciously controlled to achieve the desirable type A graphite distribution in pearlite matrix.

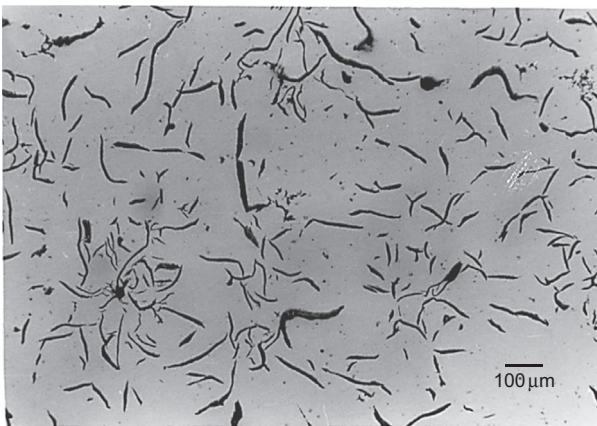
Fig. 6.2.5 A typical micrograph showing mixed A-B type graphite distribution in a section of sample B. Unetched.

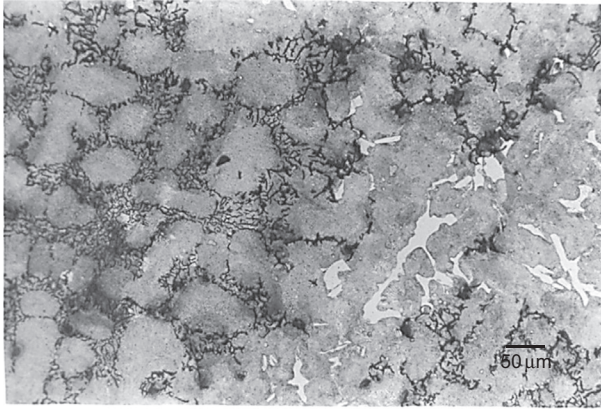
Fig. 6.2.6 Micrograph of a section of sample A revealing interdendritic segregation of finer graphite flakes with preferred orientation in a matrix of lamellar pearlite with free cementite. Etchant: 2% nital.

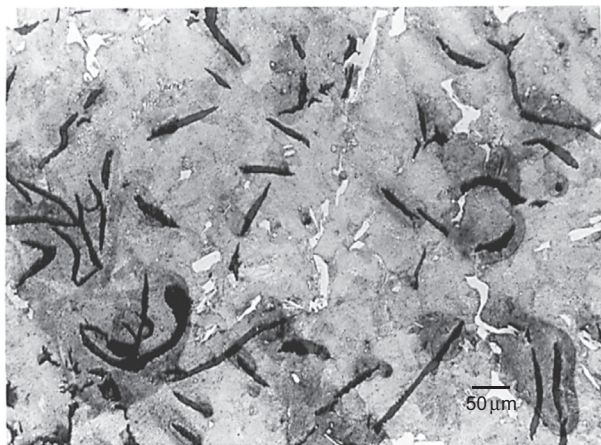
with 2% nital, the sample (B) showed lamellar pearlite and islands of free carbides along with A-B type graphite distribution (Fig. 6.2.7). Metallographic examination of the samples used for SEM fractography revealed that the sample failing in cleavage mode was corresponding to E-type distribution of graphite, whereas the sample failing in quasi-cleavage mode was corresponding to A-B type graphite distribution.

Fig. 6.2.7 Micrograph of a section of sample B revealing lamellar pearlite and islands of free carbides along with A-B type graphite distribution. Etchant: 2% nital.

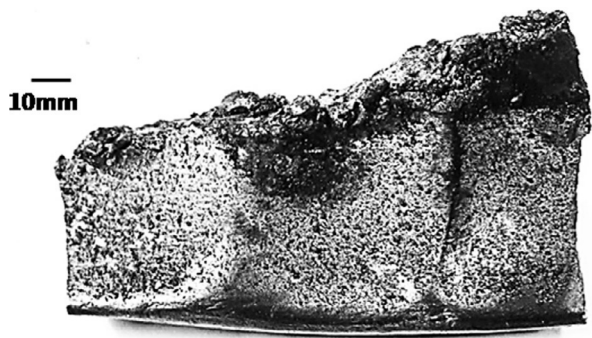
Visual Examination: The sample piece of the failed grinding roll in the as-received condition is shown in Fig. 6.3.1. One of the surfaces of the sample corresponded with the undamaged surface of the roll while the working surface showed a wavy pattern due to abrasion. The abraded surface was spoilt by sputtered metal due to gas cutting and so the surface could not be examined minutely.

Fig. 6.3.1 Sample piece from the failed grinding roll in the as-received condition.

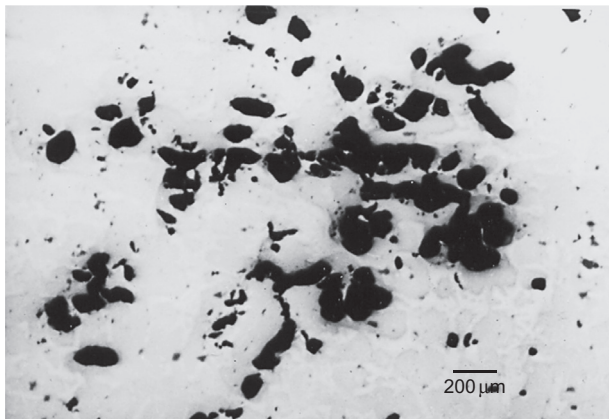
Metallographic Examination: Sections of the roll sample were cut away from the gas cut end by EDM wire cutting method that contained the original and the abraded surfaces and prepared for metallographic examination. In the unetched condition, the sample showed a large number of shrinkage cavities throughout the polished surface (Fig. 6.3.2). On etching with 2% nital, the sample revealed massive carbide in a matrix of fine pearlite, which is typical of a white cast iron (Figs. 6.3.3 and 6.3.4).

Fig. 6.3.2 Micrograph of a section of the failed roll showing a large number of shrinkage cavities. Unetched.

The presence of fine pearlite in the microstructure indicated that the grinding roll was not cooled sufficiently rapidly below the eutectoid temperature resulting in the formation of softer constituents. Had the cooling rate been sufficiently rapid, the eutectoid austenite would have missed the pearlite transformation bay and thus would have converted into martensite below the M_s temperature. It appeared that the grinding roll was cast without using proper chill. The presence of large amount of shrinkage cavities indicated that proper feeding arrangements were not used in order to eliminate such defects during solidification of the casting. Presence of such casting defects also contribute to lower life of the grinding roll.

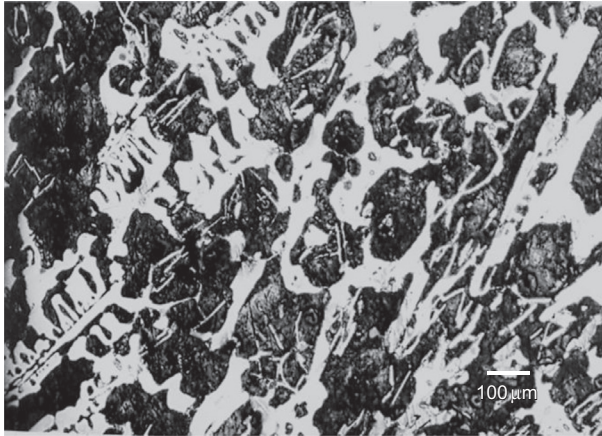
Fig. 6.3.3 Micrograph of a section of the failed roll showing massive carbide in a matrix of fine pearlite. Etchant: 2% nital.

grinding rolls. The prematurely failed grinding roll revealed a microstructure containing massive carbide in a matrix of pearlite. The hardness of the roll was much lower than the specified minimum.

1. The pearlitic structure of the grinding roll cannot be altered to martensitic structure by heat treatment without causing any damage to the roll.
2. Avoid using the grinding rolls from the same manufacturing lot, which would give lower service life than that is required.

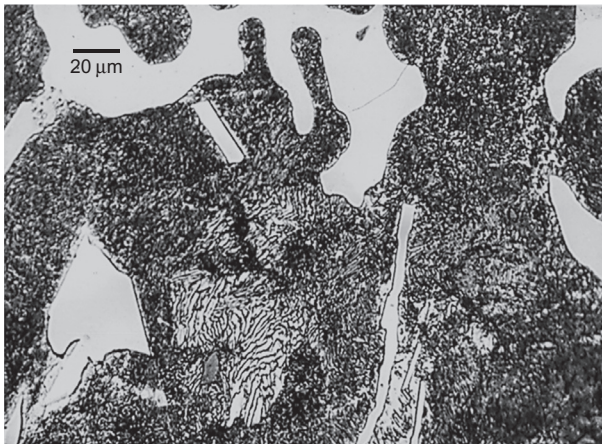
Fig. 6.3.4 Same as [Fig. 6.3.3](#) at higher magnification. Note the lamellar nature of pearlite phase. Etchant: 2% nital.
